Littlecote Roman Villa

Littlecote Roman Villa - 6. Exploring and Understanding the villa today

6. Exploring and understanding the villa today

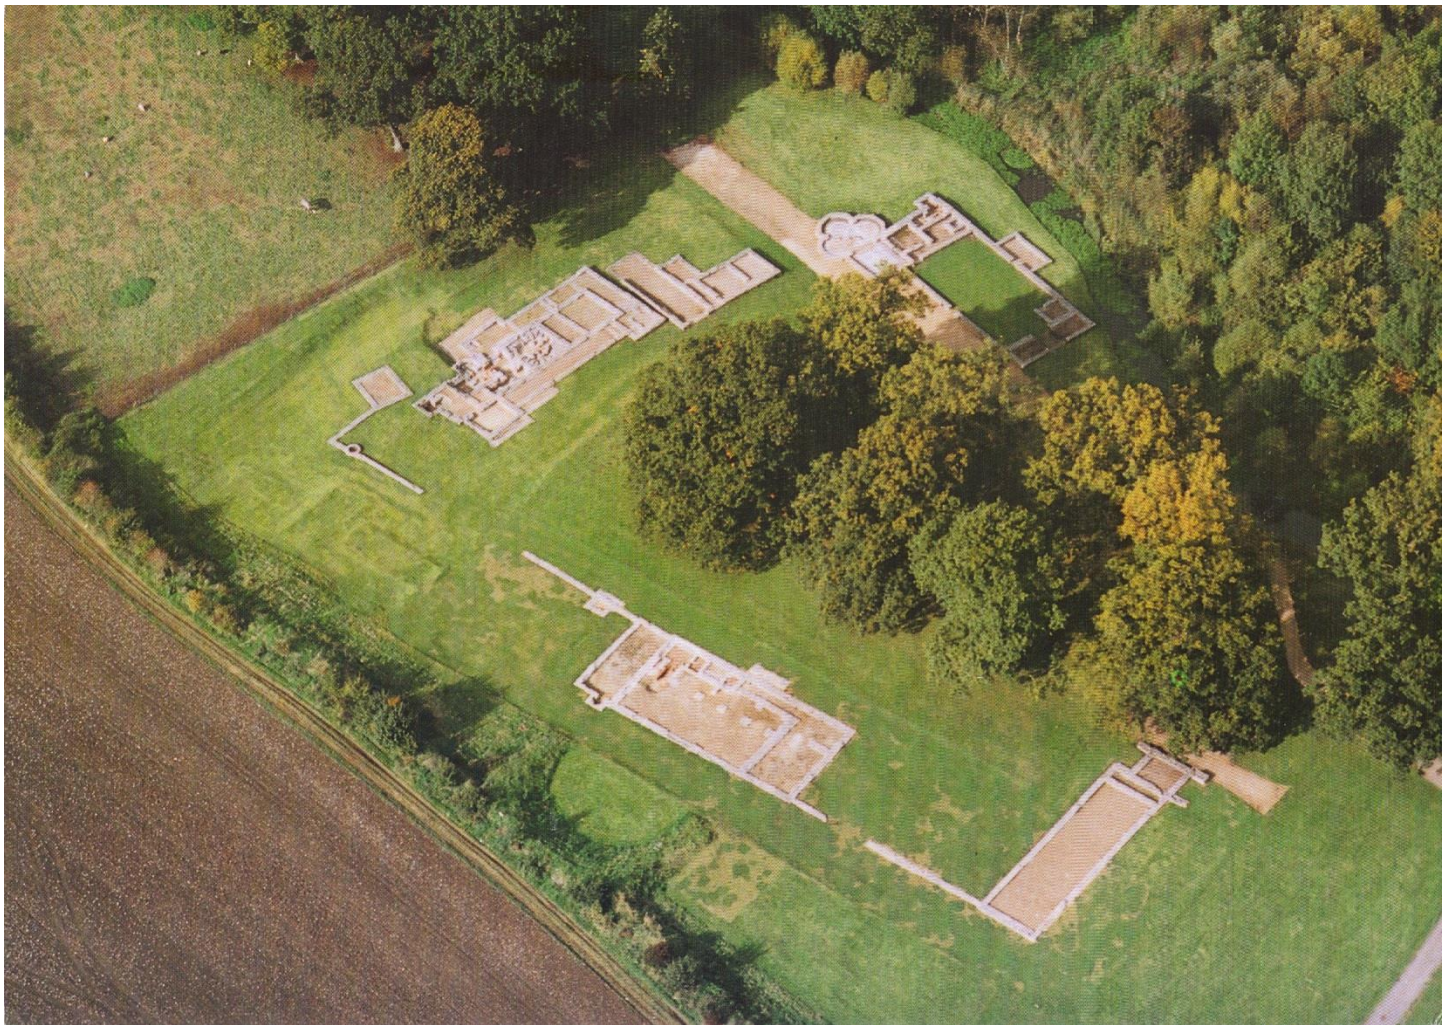
**An aerial view of the villa as restored, 1991
(Note the gravel within the villa rooms and the old roadway)**

The villa has four ranges of buildings set around a large rectangular courtyard, approximately 100 metres square. Most of the walls of all four ranges can be seen in the aerial photo above. There were no buildings on the north-east part adjacent to the river.

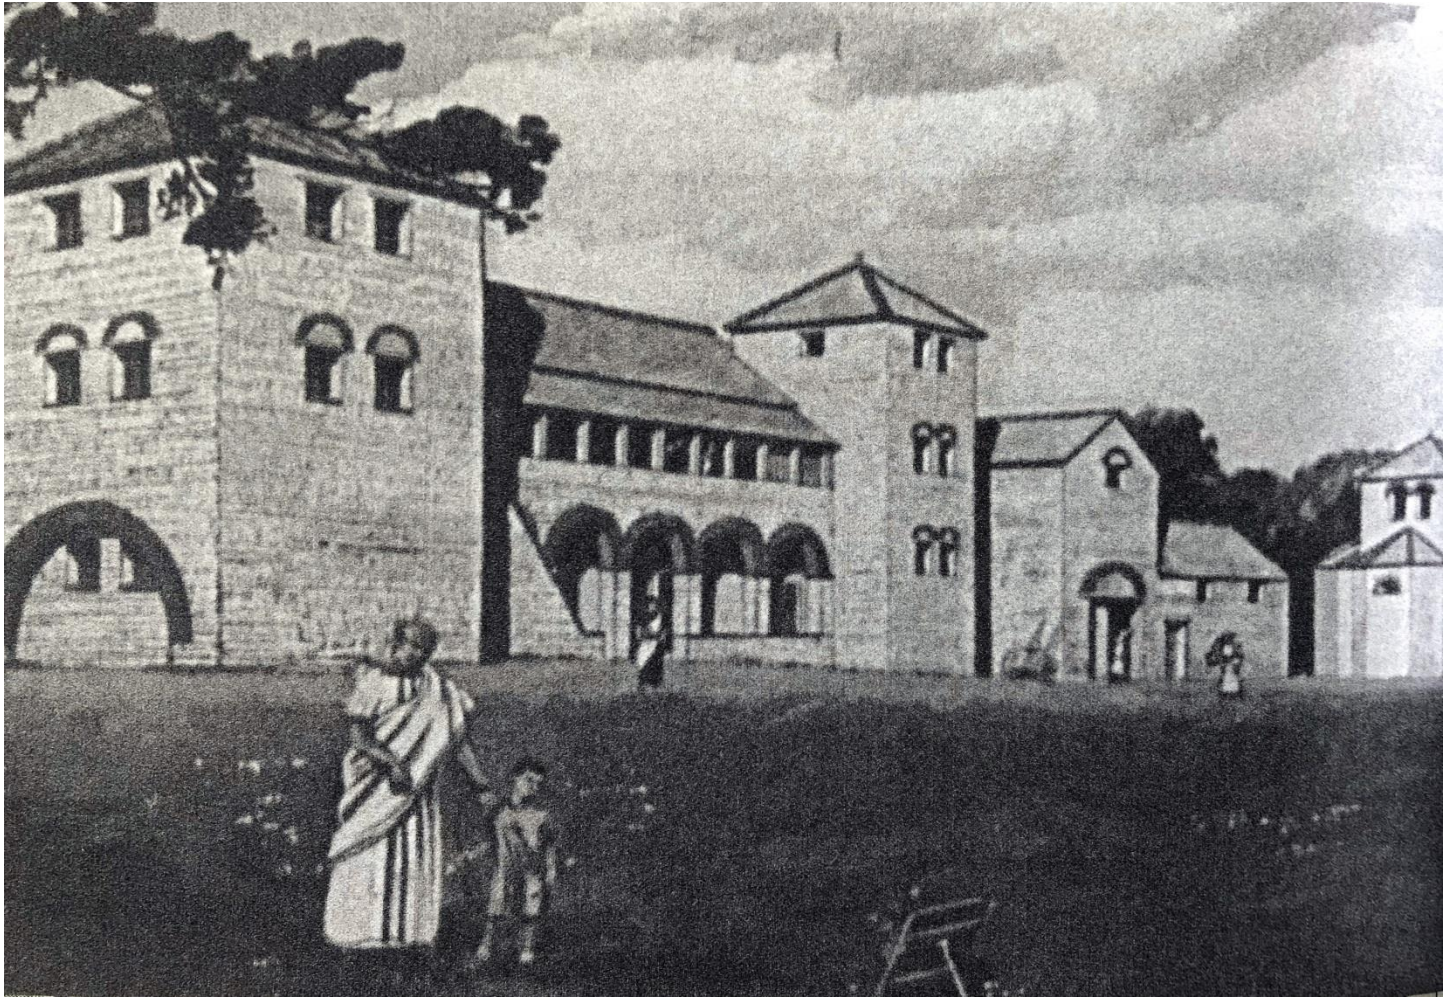
Artist Trevor Caley's impression of the west range c.AD 360-365

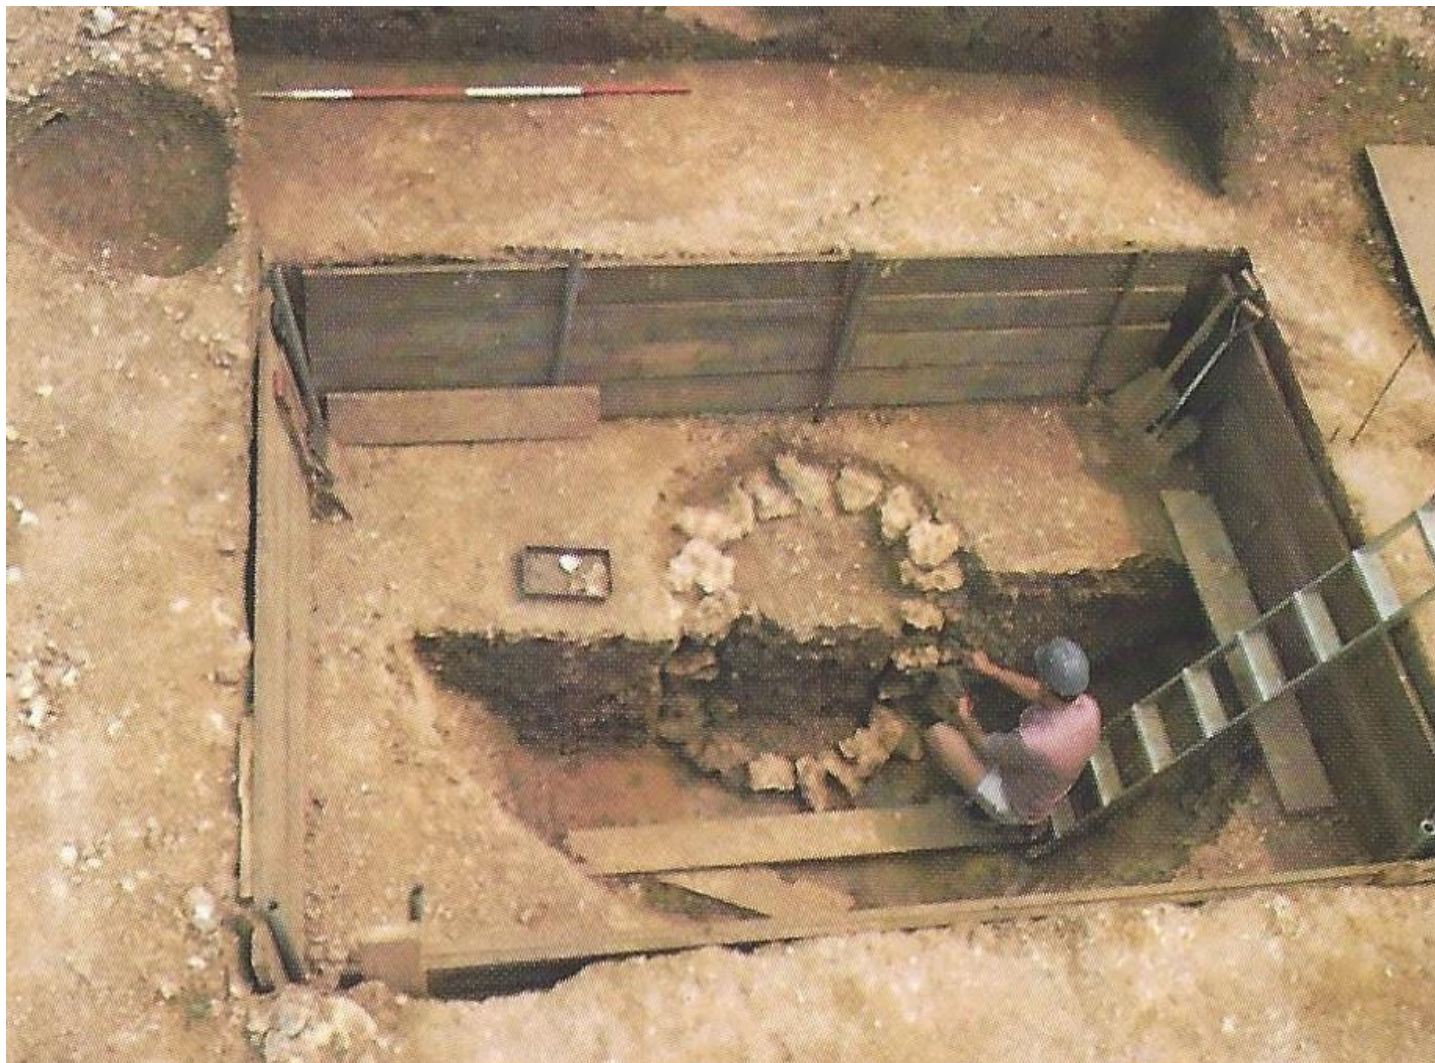
Excavating The 2nd century well (41)

41 – A **well**, built of flint blocks, which supplied the earlier villa house and its baths. It predated the courtyard wall.

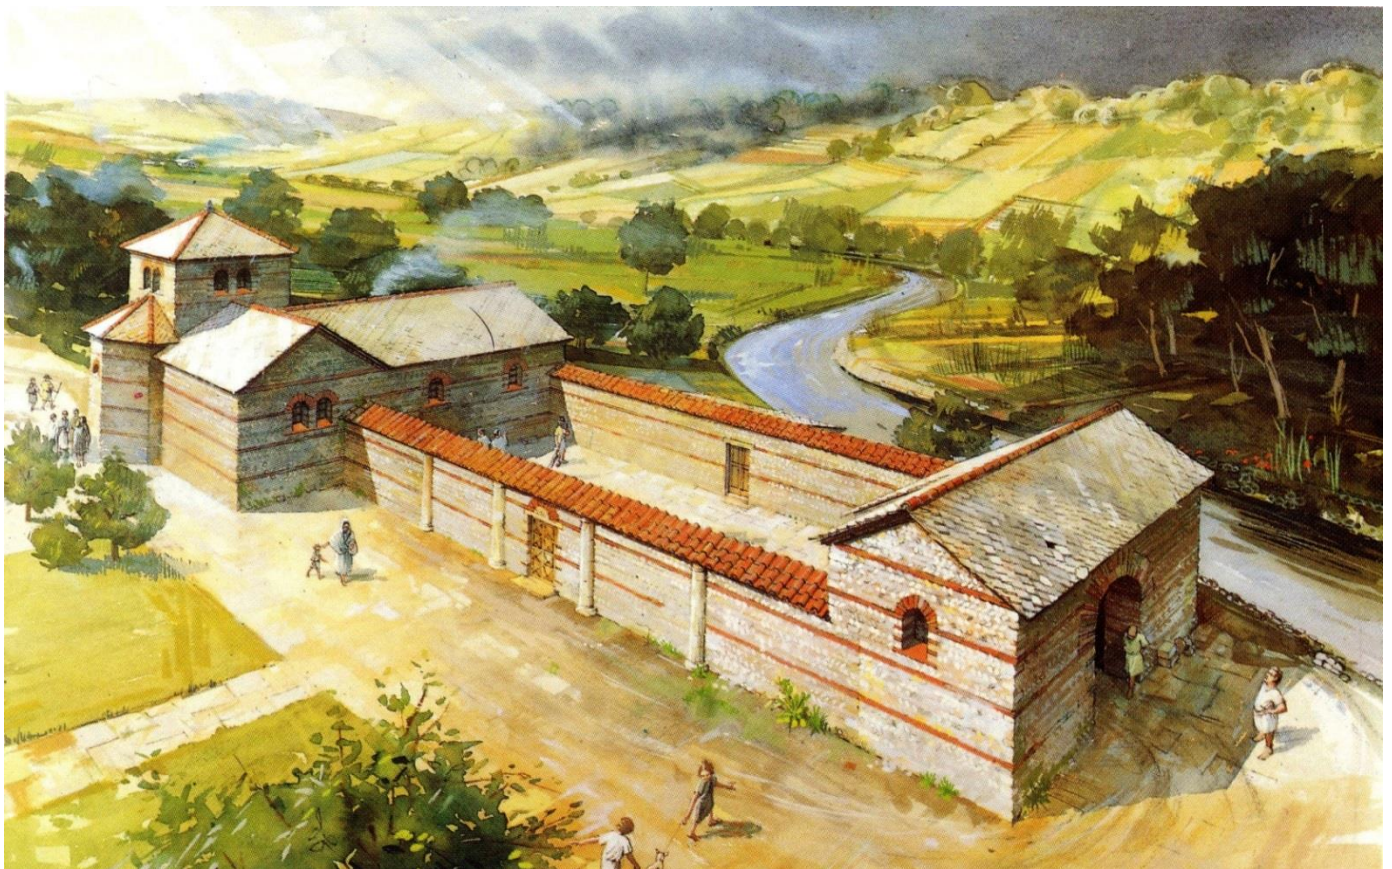
Artist Trevor Caley's impression of the riverside building c.AD 360-365
